THE “GREAT” GUAM AND HANSHIN EARTHQUAKES PROFILES IN PORT DISASTERS

FEROZE R. VAZIFDAR¹, M. ASCE

PETER KALDVEER², M. ASCE

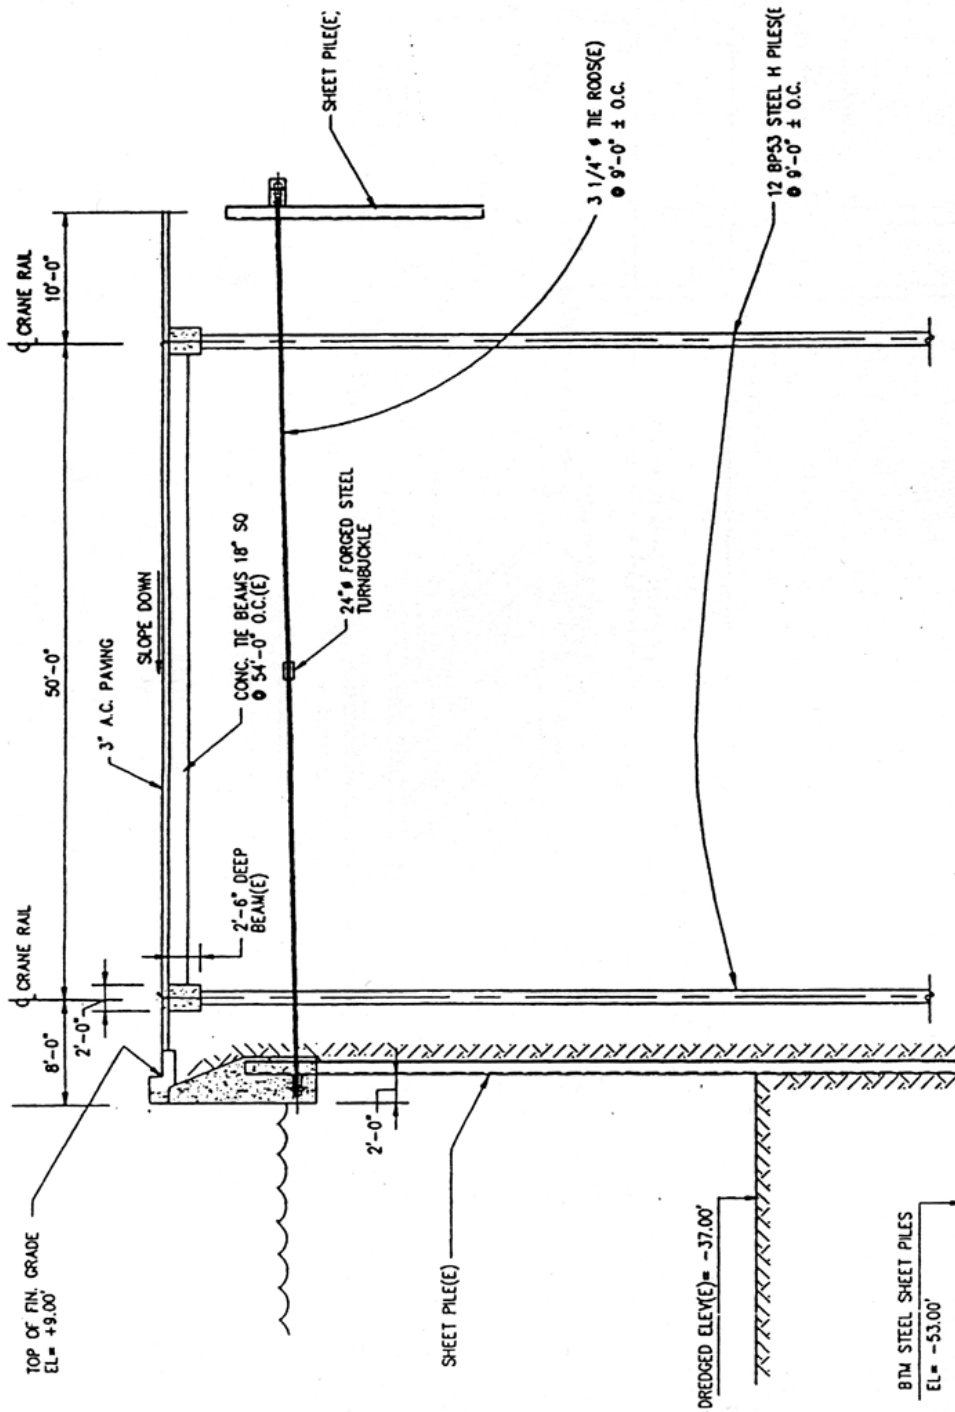
Figure 1 - Original Wharf, Port Authority of Guam

The original wharf, built in 1966, consists of sheet pile bulkhead tied back with rods to a continuous sheetpile deadman. In 1970, a 50-foot gage crane runway was added with reinforced concrete girders and vertical steel H-piles spaced 9 feet on center. The gage was held by concrete struts at 54 foot centers for the full length of the runways. The crane runway structure is independent of the sheet pile bulkhead and deadman.

The original wharf cross section is shown in figure 1.

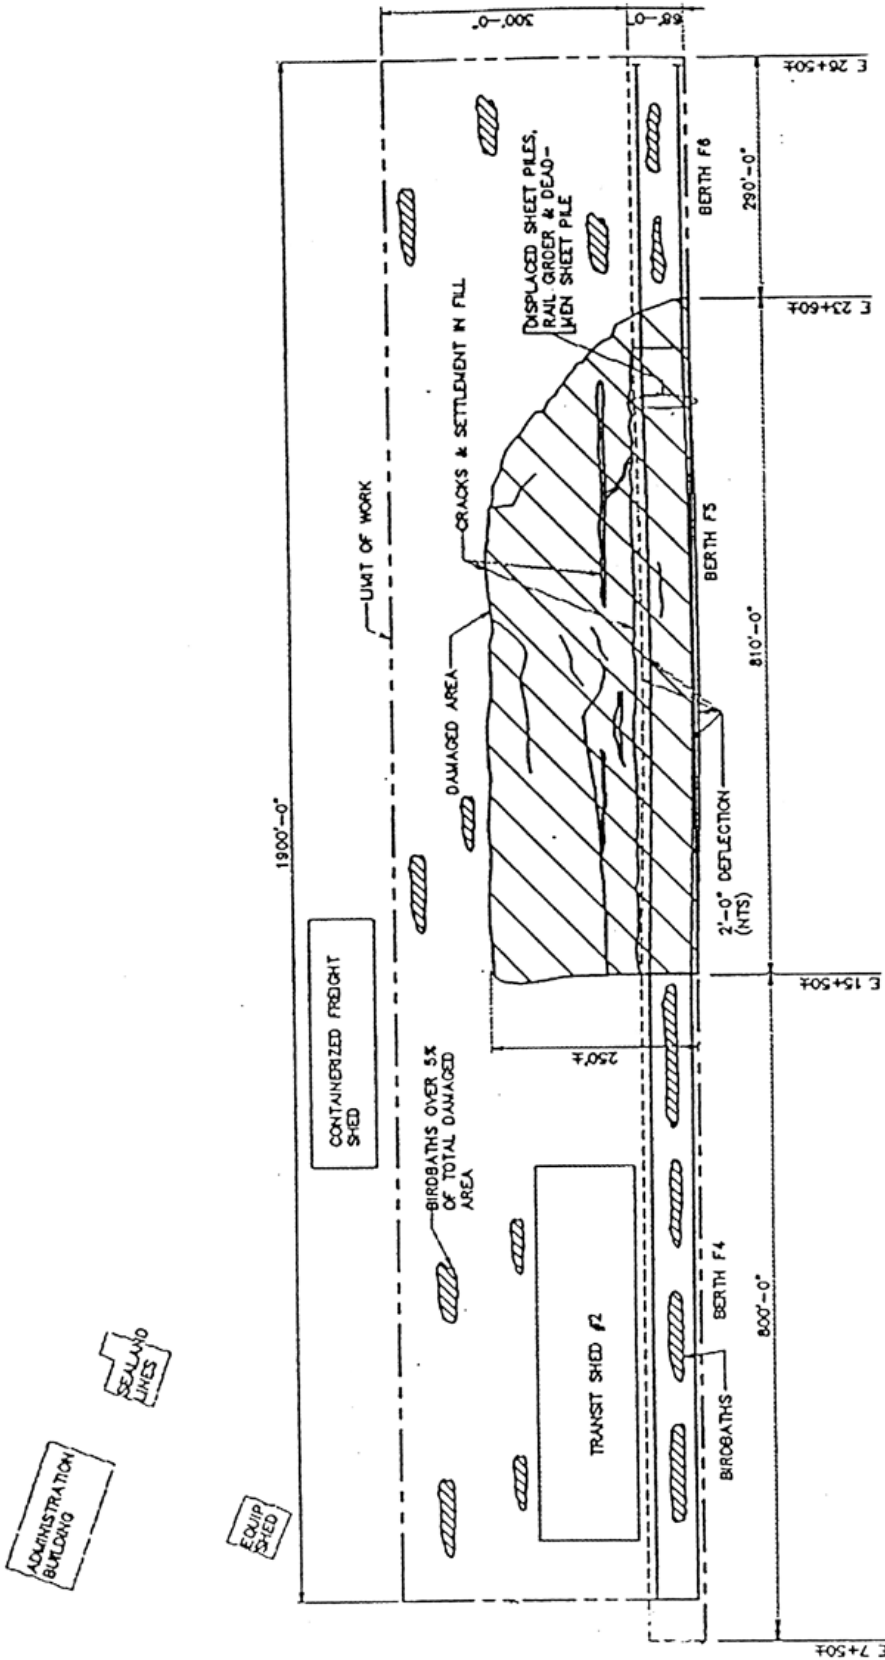
FIGURE 2 - WHARF BACKLANDS DAMAGE
PORT AUTHORITY OF GUAM

A topographic survey of the crane rails and waterside bulkhead indicated the entire 1900-foot length of bulkhead and crane runway rotated clockwise about the western edge of the wharf and translated as much as 18 inches toward the water. The 810-foot long shaded portion shown in figure 2, suffered surface cracking and minor damage. A 560-foot region within the shaded area suffered serious structural damage.

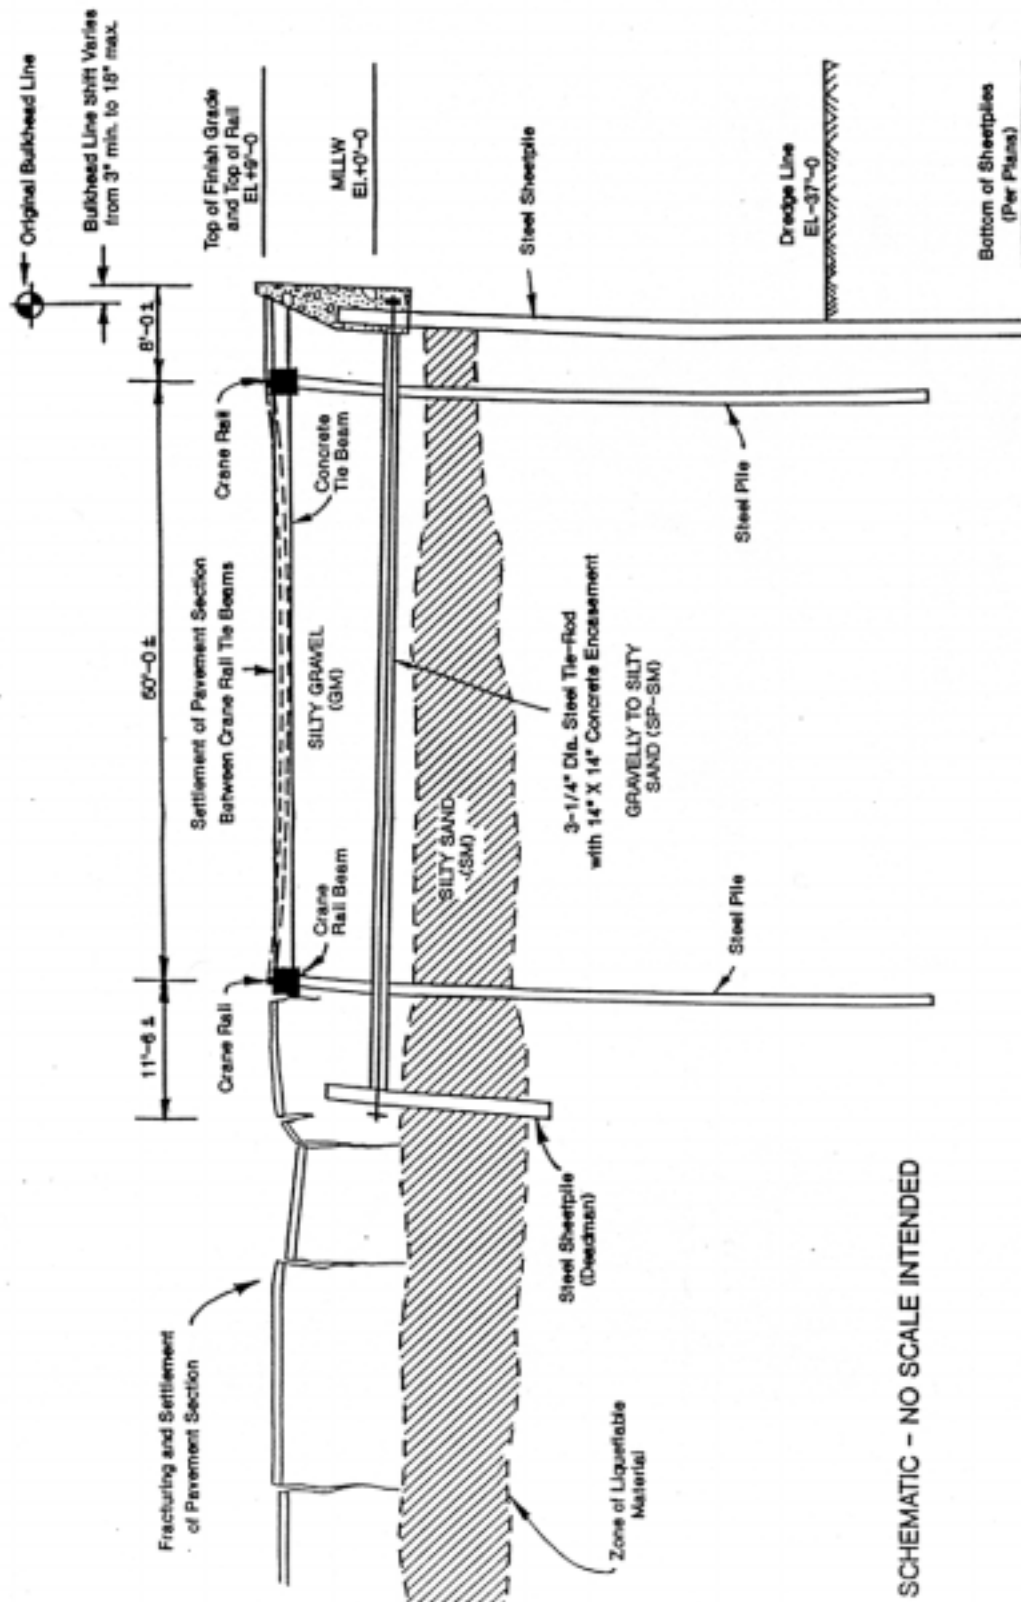
FIGURE 3 - WHARF MOVEMENT AND CRACKING DUE TO EARTHQUAKE
PORT OF GUAM

The original wharf construction relies on the sheet pile deadman to hold back the bulkhead wall through passive resistance of the soil waterside of the deadman. During the earthquake, the layer of silty sands between the bulkhead wall and the deadman liquefied. This caused increased lateral forces on the bulkhead wall and reduced passive resistance in front of the deadman. The bulkhead wall and deadman moved toward the water. Liquefaction of the underlying sandy soils caused the upper gravel fill layer and asphaltic concrete to crack and settle, forming large birdbaths between the rail girders. As the deadman moved forward, a void was created behind it and the soils subsided, causing a series of cracks in the backlands.

The wharf movement and cracking due to the earthquake is shown on figure 3.

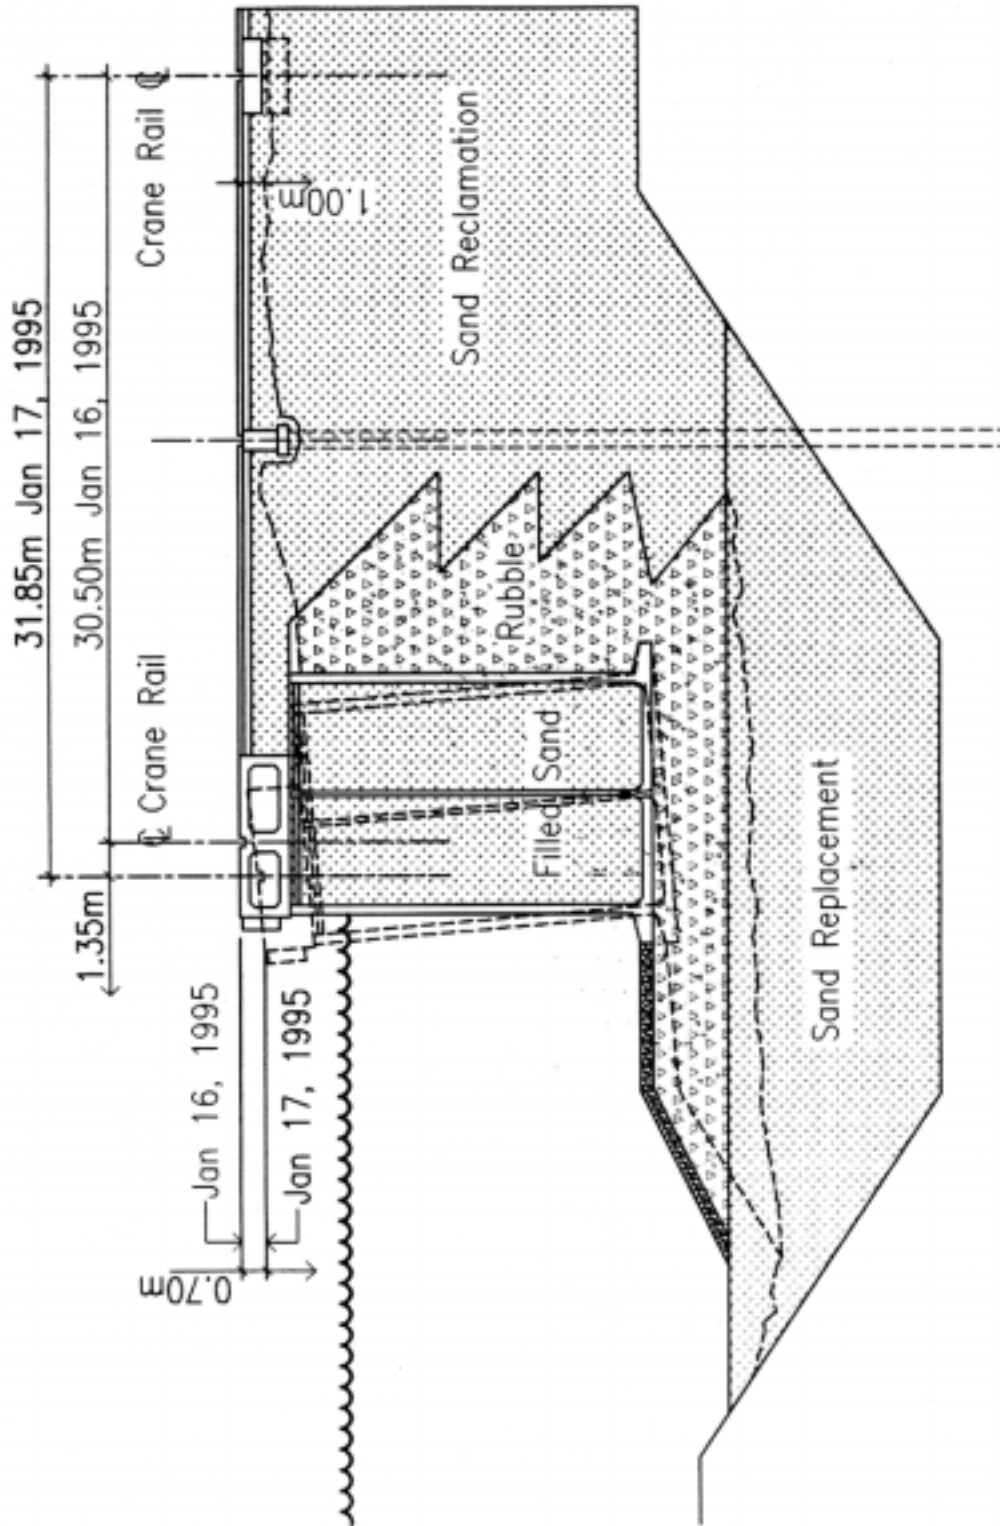
Figure 4: Wharf Construction and Damage – Port of Kobe

Damage at Port Island and Maya Terminal is extensive between the rails and in the backlands. The entire interior of Port Island settled as much as 3 feet due to liquefaction of the underlying fill. Rokko Island suffered extensive damage between the rails, but suffered only minor settlement in the backlands and interior. The AC paved yard between the caissons and the landside rail girders dropped 7 to 10 feet. The caissons settled approximately 3 feet, rotated between 3 to 5 degrees, and laterally shifted towards the water by as much as 12 feet.

The failure of the caisson wall foundation appears to be due to pressure from liquefaction of the fill material behind the caisson and lateral seismic forces. Until further investigations are completed, it is not clear whether liquefaction of the fill under the caisson or stress failure due to excessive bearing pressures in the underlying fill contributed to the rotation of the caisson. The lateral shifting and rotation of the caissons has resulted in the rail girders spreading by 3 to 7 feet at Port Island and Maya Terminal and 12 to 15 feet at Rokko Island.

Pile supported structures such as the 50-foot gage landside rail girder have performed well. Settlement of the 50 ft gage landside rail girder is minimal, with some minor lateral and rotational movement. The landside 100-foot gage grade beam has settled along with the backlands.

The original damaged cross-section of the wharf at Port Island is shown on figure 4.
