CRANE REPAIR SERVICES

Liftech Consultants Inc.

Selected Crane Repair Projects

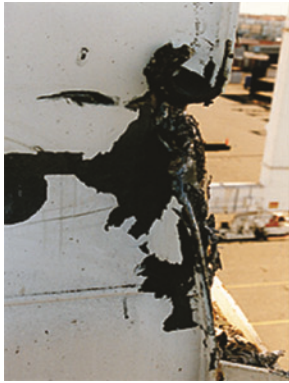
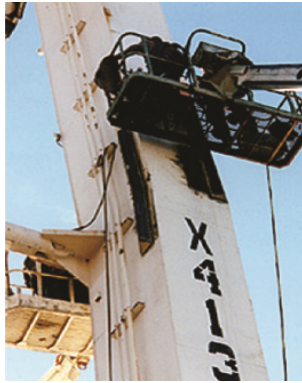
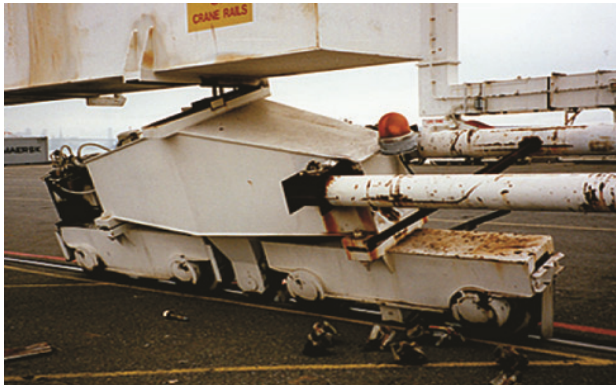
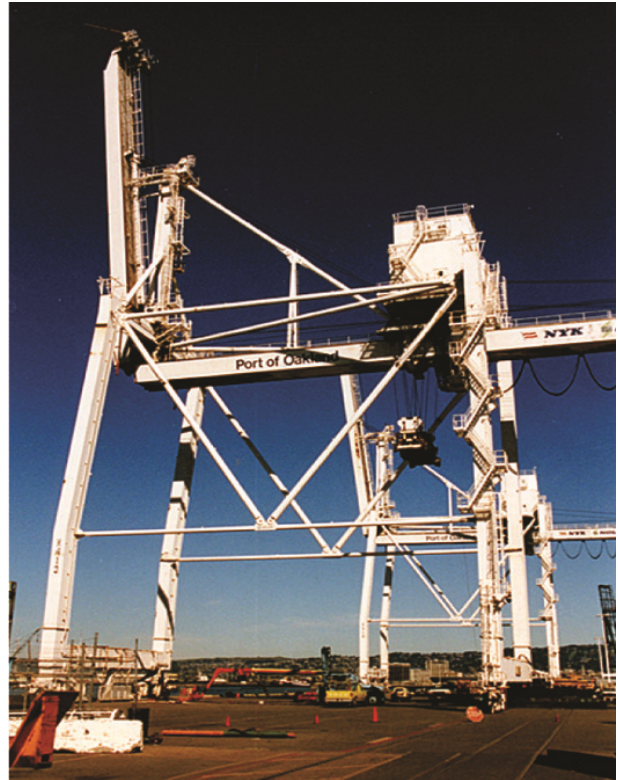
Crane Repair Port of Oakland, California

On February 7, 1997, a ship struck a Krupp crane at the Port of Oakland. The bow hit one of the waterside legs just above the portal beam, about 45' above the rail. The impact pushed the waterside legs 35" to the right and 30" toward the land. Because the wheels remained on the rail, the sill beams at the waterside and landside partially separated from the equalizer beams.

Liftech helped the port temporarily secure the crane, then reposition and repair the damage. The crane was secured by installing posts at two corners and a crib pile under the sill beam near one corner.

The crane was repositioned by lifting the waterside legs with a mobile crane, jacking up the landside legs, and jacking the landside horizontally until it could be placed back down on the equalizer assemblies. Replacing the buckled plates in the area of ship impact repaired the damaged leg.

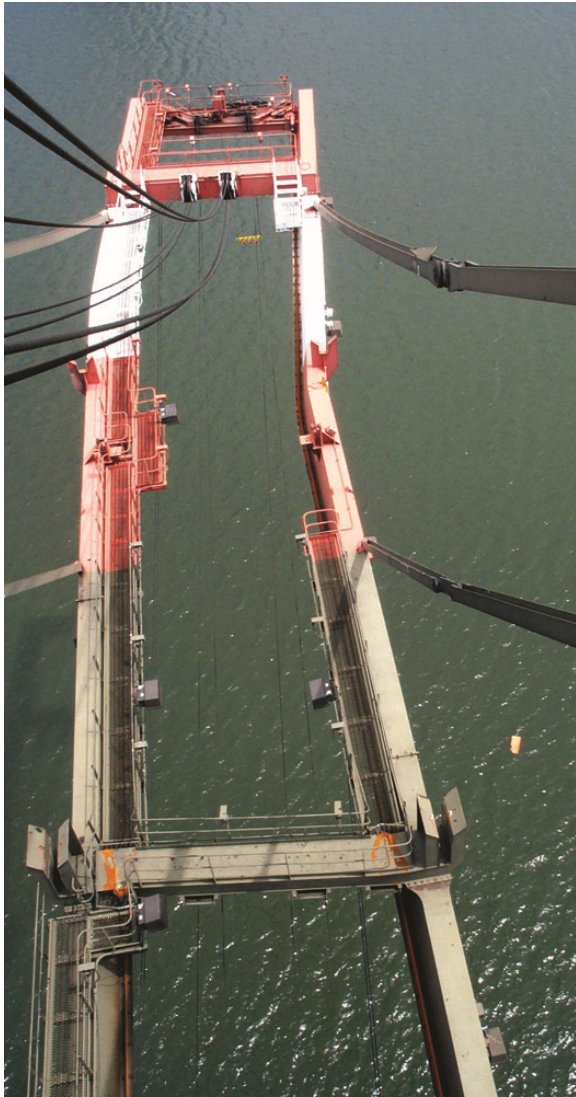
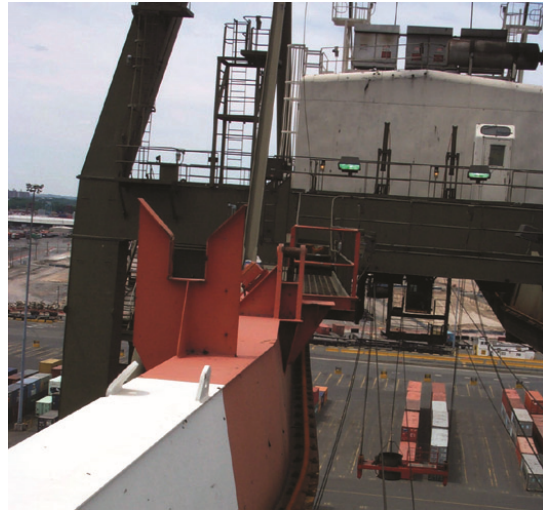
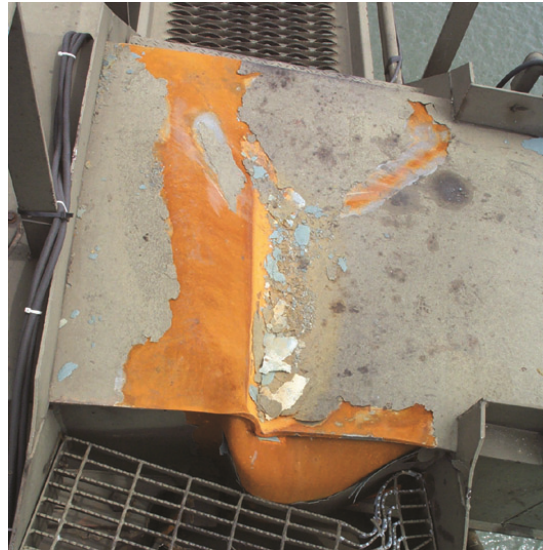
Repair of Damaged Crane Booms Various Locations

Container crane booms are frequently damaged due to ship collisions.

Liftech has been involved in dozens of repairs and provides all aspects of engineering for repairs. Repairs range from rebuilding damaged sections to stiffening damaged sections to heat straightening damaged locations.

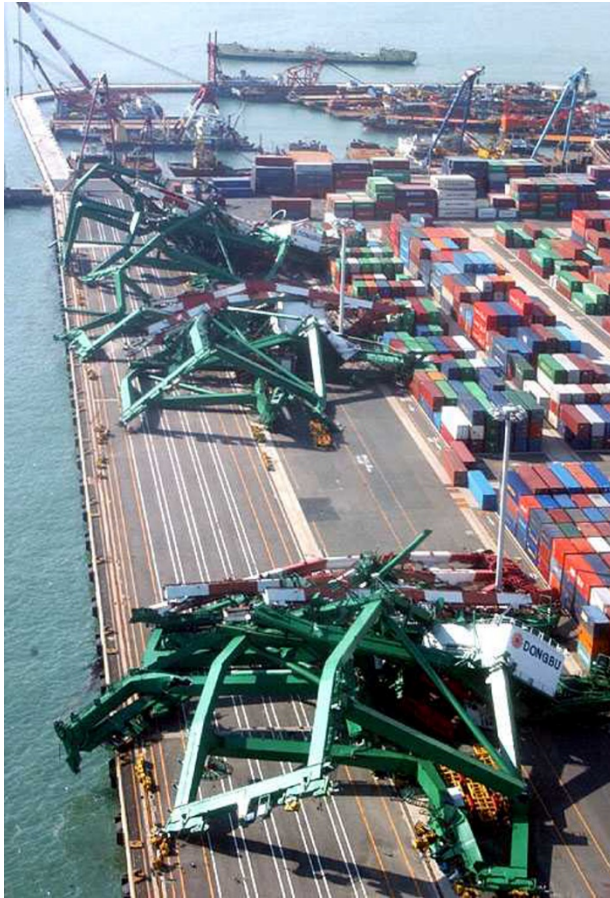
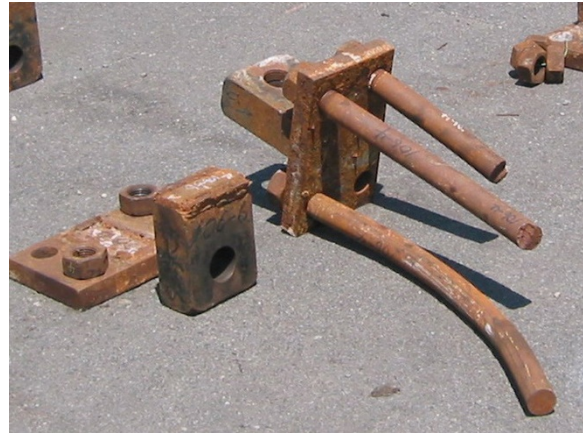
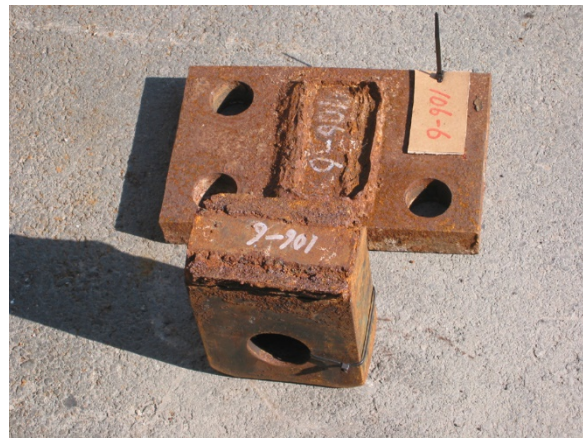
VIT Paceco Crane and Wharf Damage Review Newport News Marine Terminal, Virginia

Paceco Crane 313 was struck by a departing ship on January 31, 2004. Virginia International Terminals retained Liftech to review the damaged crane and wharf, design temporary bracing to stabilize the crane, and design repair details for the damaged crane stop.

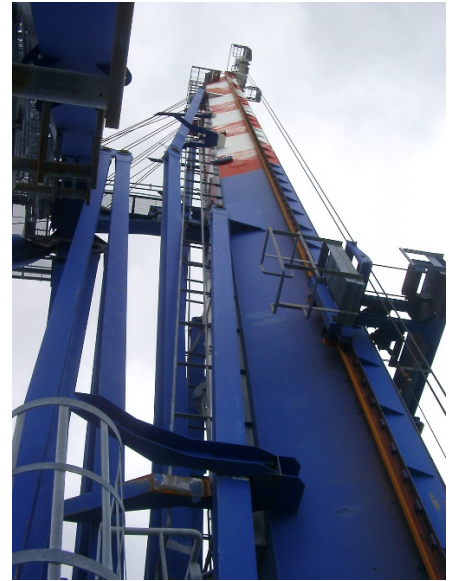
Crane Damage Assessment Freeport, Grand Bahama

The forestays of an Officine Meccaniche Galileo (OMG) crane were twisted and became entangled as a result of Hurricane Frances in September 2004. Liftech was retained to assist with the assessment and repair of the forestay system.

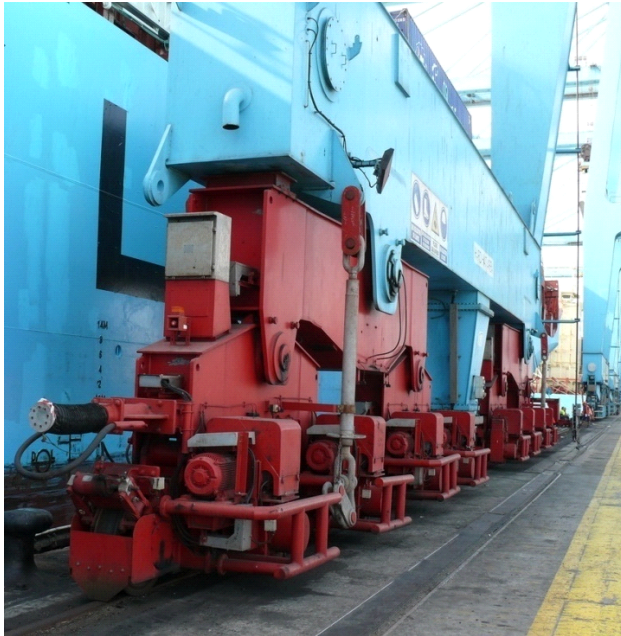
Equalizer Beams

Intermediate equalizer beam crack (lower photo) that is obstructed by the pin ear plate in the upper photo.

As container cranes become bigger and faster, new types of fatigue problems emerge. Fatigue cracking of pin plates in equalizer beams has occurred in many cranes, made by different manufacturers, at various locations.

Liftech has been involved in numerous equalizer beam repairs. We have investigated the cause of the fatigue cracking, performed structural analyses, provided modification concepts, assessed the effectiveness of the modifications, and helped develop new equalizer beam designs.

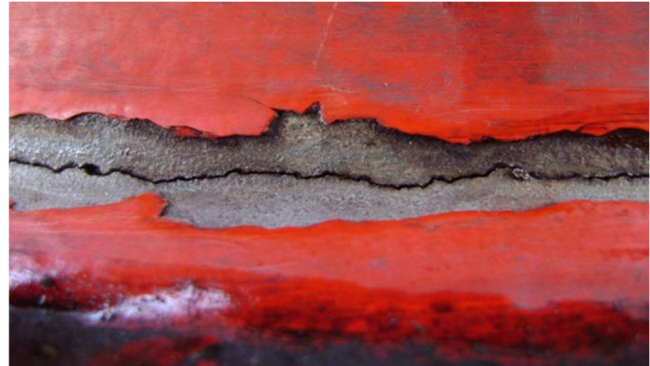
2. End pipe stub column at bolted flange plate

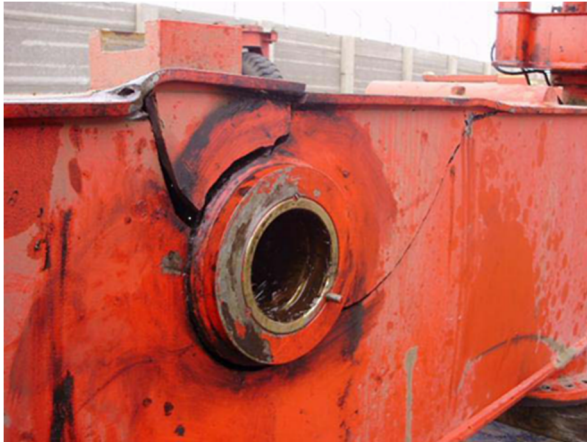
1. Equalizer beam web under center equalizer pin

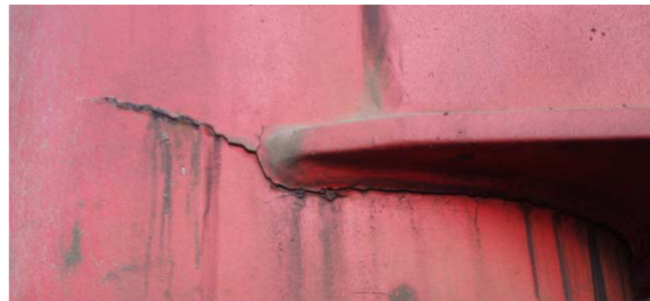
3. End pipe stub column at equalizer beam bottom flange

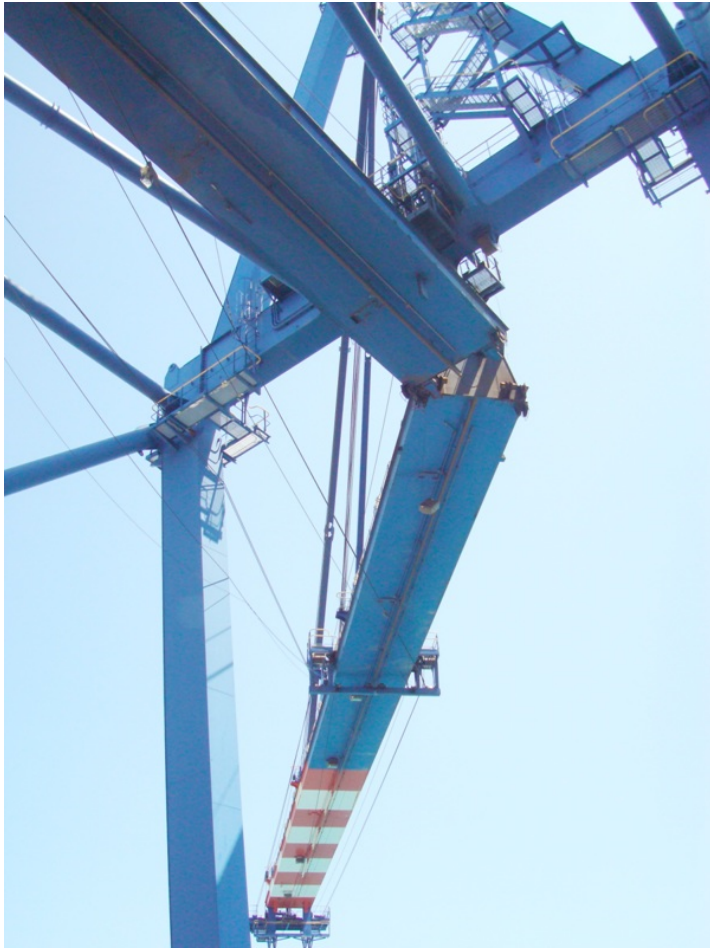
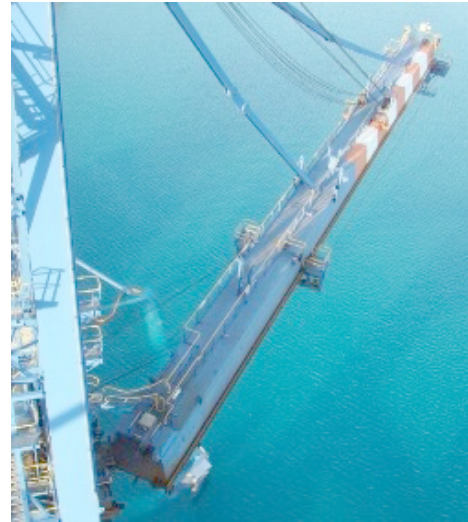
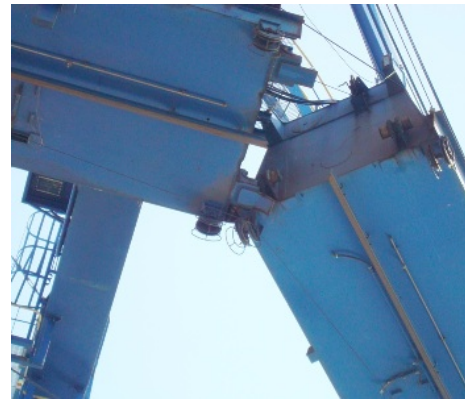
Hyundai Crane Damage Assessment and Repair Freeport, Grand Bahama

A tornado damaged six Hyundai monogirder cranes and toppled another. Liftech assessed the damage to the untoppled cranes and assisted with engineering for the repairs.

Hyundai Crane 9 suffered severe damage when it collided with Crane 10. The boom detached from the right lower hinge pin, the upper hinge broke off, the forestay apex connection plate bent, and the boom rotated more than 45 degrees.

The boom was brought back into its lower hinge seating, the upper hinge connections were replaced, and the forestay connection plates were heat straightened.

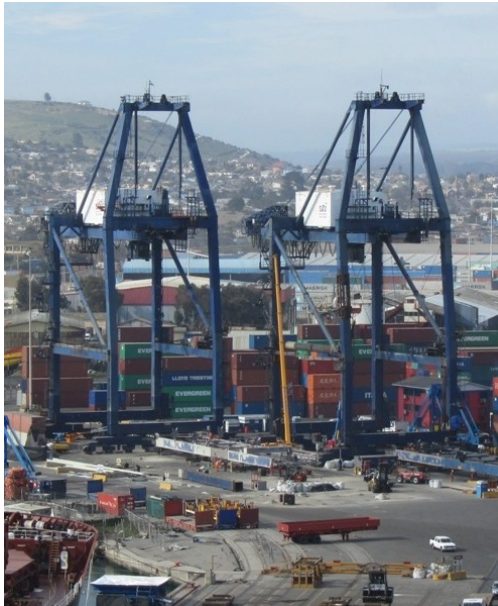
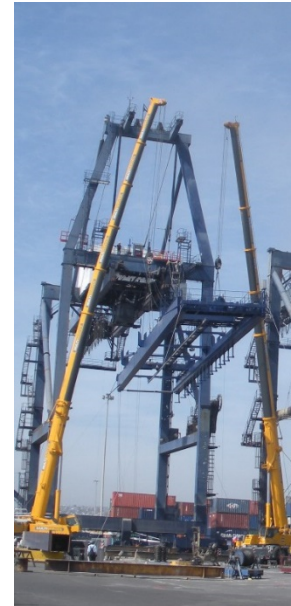
Paceco Crane Damage Assessment and Repair San Antonio, Chile

Two Paceco cranes operated by San Antonio Terminal Internacional at their San Antonio Terminal in Chile suffered damage when the cranes were struck by departing ships in the aftermath of the February 2010 magnitude 8.8 earthquake.

One crane suffered significant damage to the boom and the portal frame. The other crane suffered significant damage to the boom and the trolley. The port was concerned with the structural integrity of the cranes and that the damaged cranes would cause long-term interruption to the port's operation.

We worked with the contractor to develop the repair concepts, including an innovative frame straightening concept and a strongback system to support the damaged legs and portal beams. We provided design drawings for the frame straightening and the frame and boom repair.

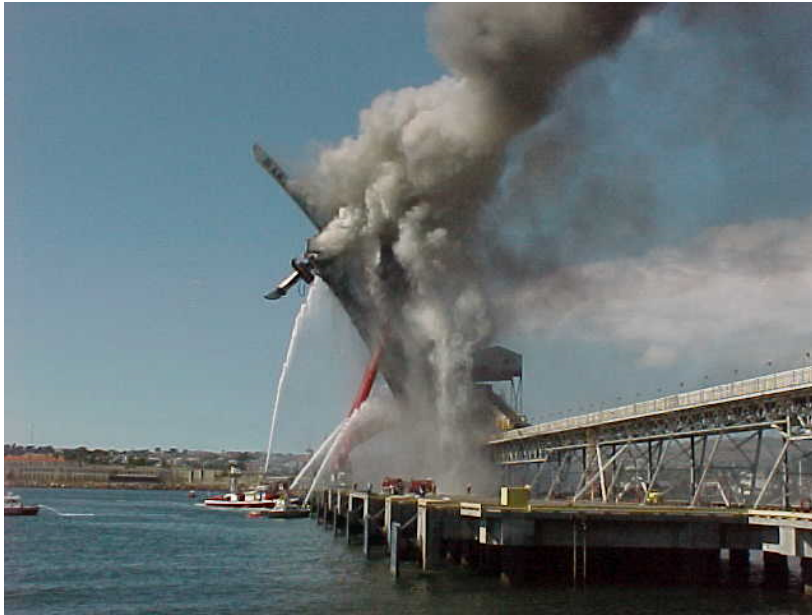
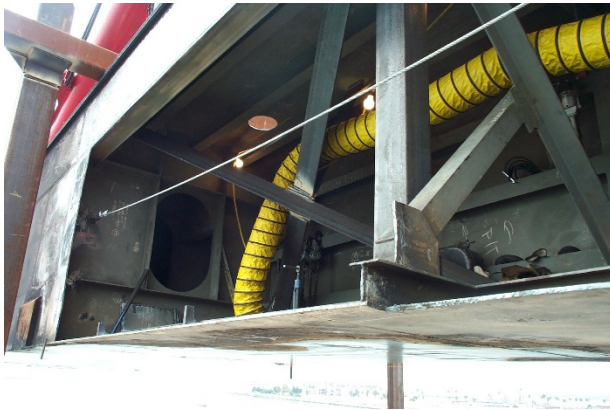
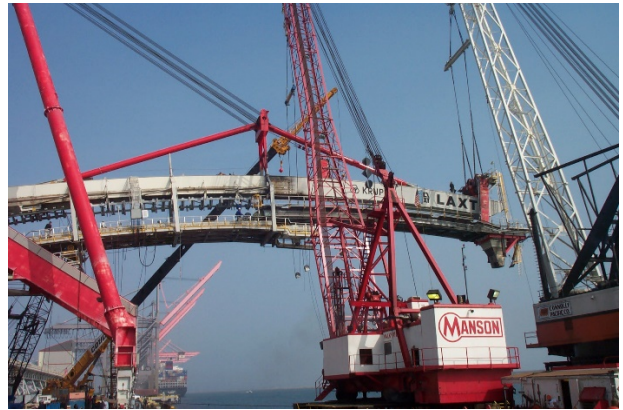
Repair of Fire Damaged Coal Loader Berth 301, Port of Los Angeles, California

Repair of damage from September 2000 fire, February 2001 fire, and April 2001 ship collision.

The coal loader built by Krupp was severely damaged in two fires and suffered significant damage during a ship collision.

After each incident, Liftech provided on-site engineering to assist with repairs. Repairs consisted of replacement or stiffening of buckled sections, restoring the geometry of the boom and shuttle structures to mitigate operational problems, and development of a structural maintenance program to ensure long-term reliability of the repaired structure.

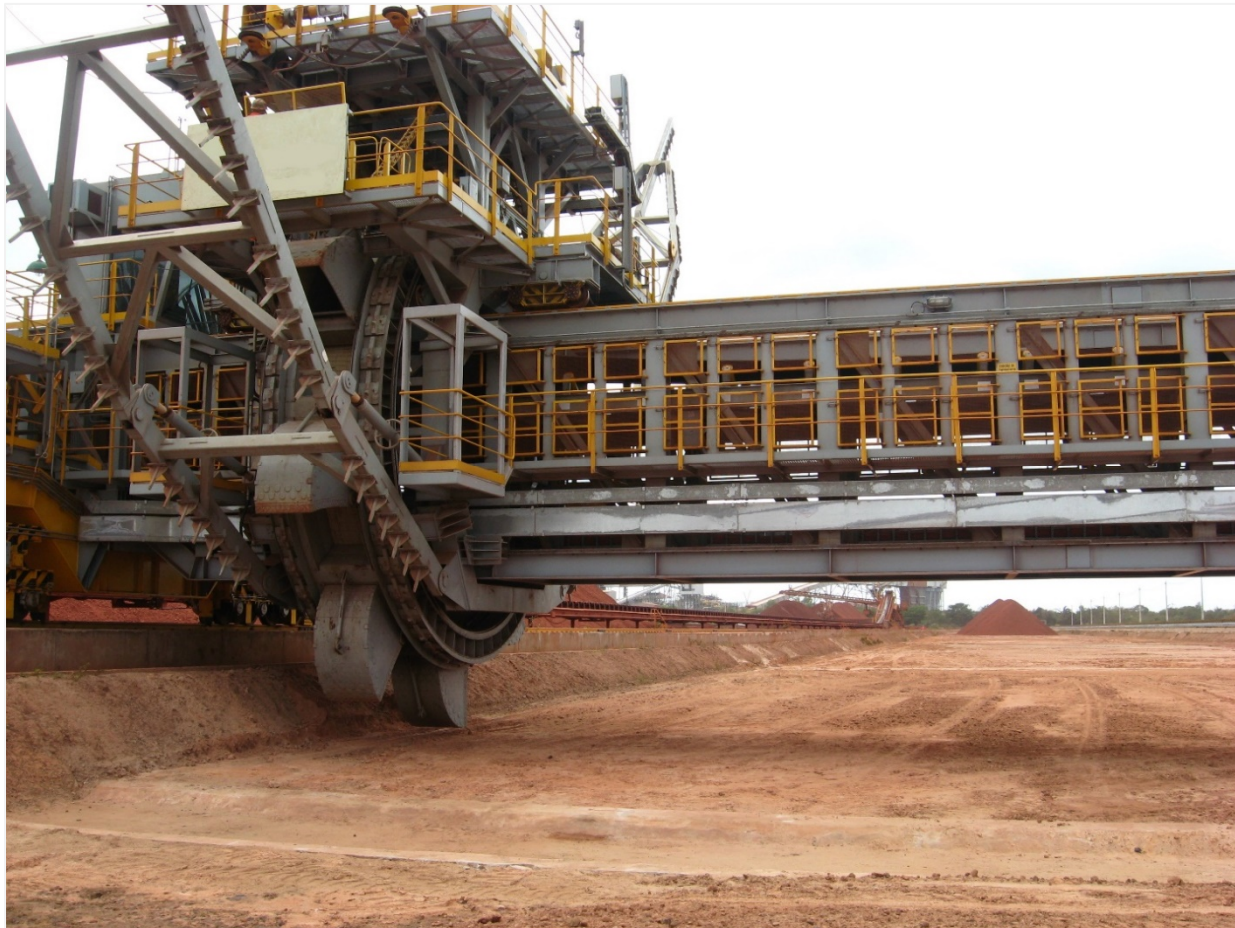
Bauxite Reclaimer Bridge Chord Repair

The client has a reclaimer that has been operating for over ten years at its facility in South America. This equipment experienced chronic fatigue cracking in the truss beam upper chord. After making in-house crack repairs and performing a modification that resulted in further fatigue cracking, the client retained Liftech to evaluate the cracking and to design repairs.

Liftech performed analyses that determined the cause of cracking and developed a simple repair detail that improves fatigue performance by a factor of 20 to 400 depending on the loading condition. Liftech provided a report summarizing our review, the cause of cracking, and our recommendations, repair design drawings, and procedure.

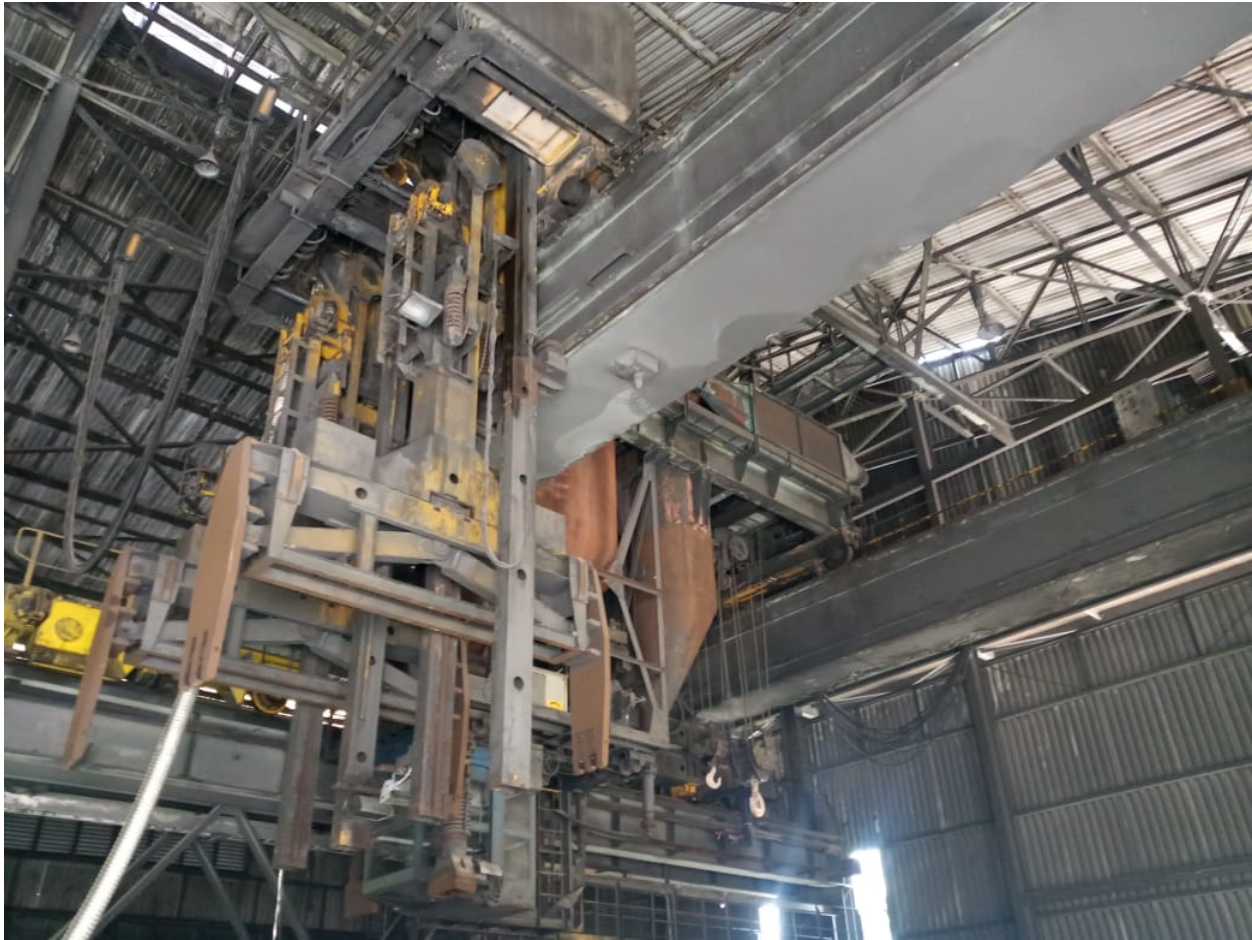
Furnace Crane Bridge Girder Repair

The client has furnace cranes that were in operation from 1984 to 2015 at its facility in South America. This equipment experienced significant chronic fatigue cracking in the crane bridge girder.
